Metropolitan Sewerage District

Subject: Notice of Violation
NOV-2013-DV-0120
Permit No. WQCS00004
Buncombe County

MSD Sewage Spill - 4/30/13 / Investigation and Background

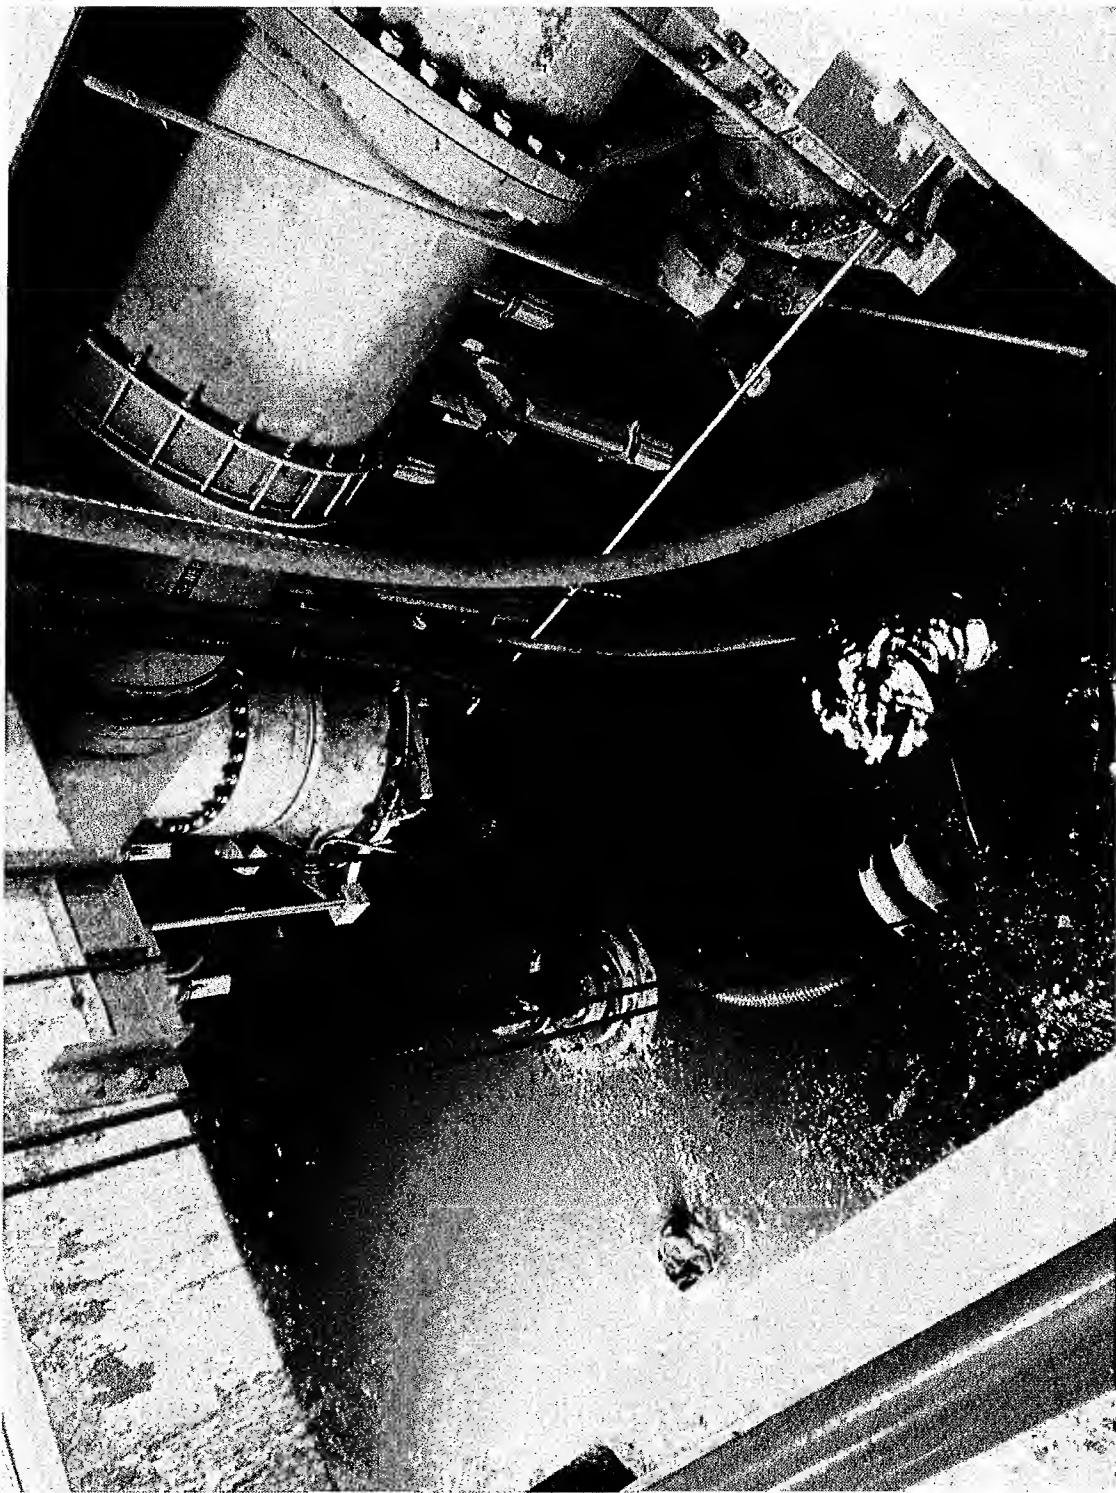
Blown Out Slide Gate and Sewage Flooding Dry Pit

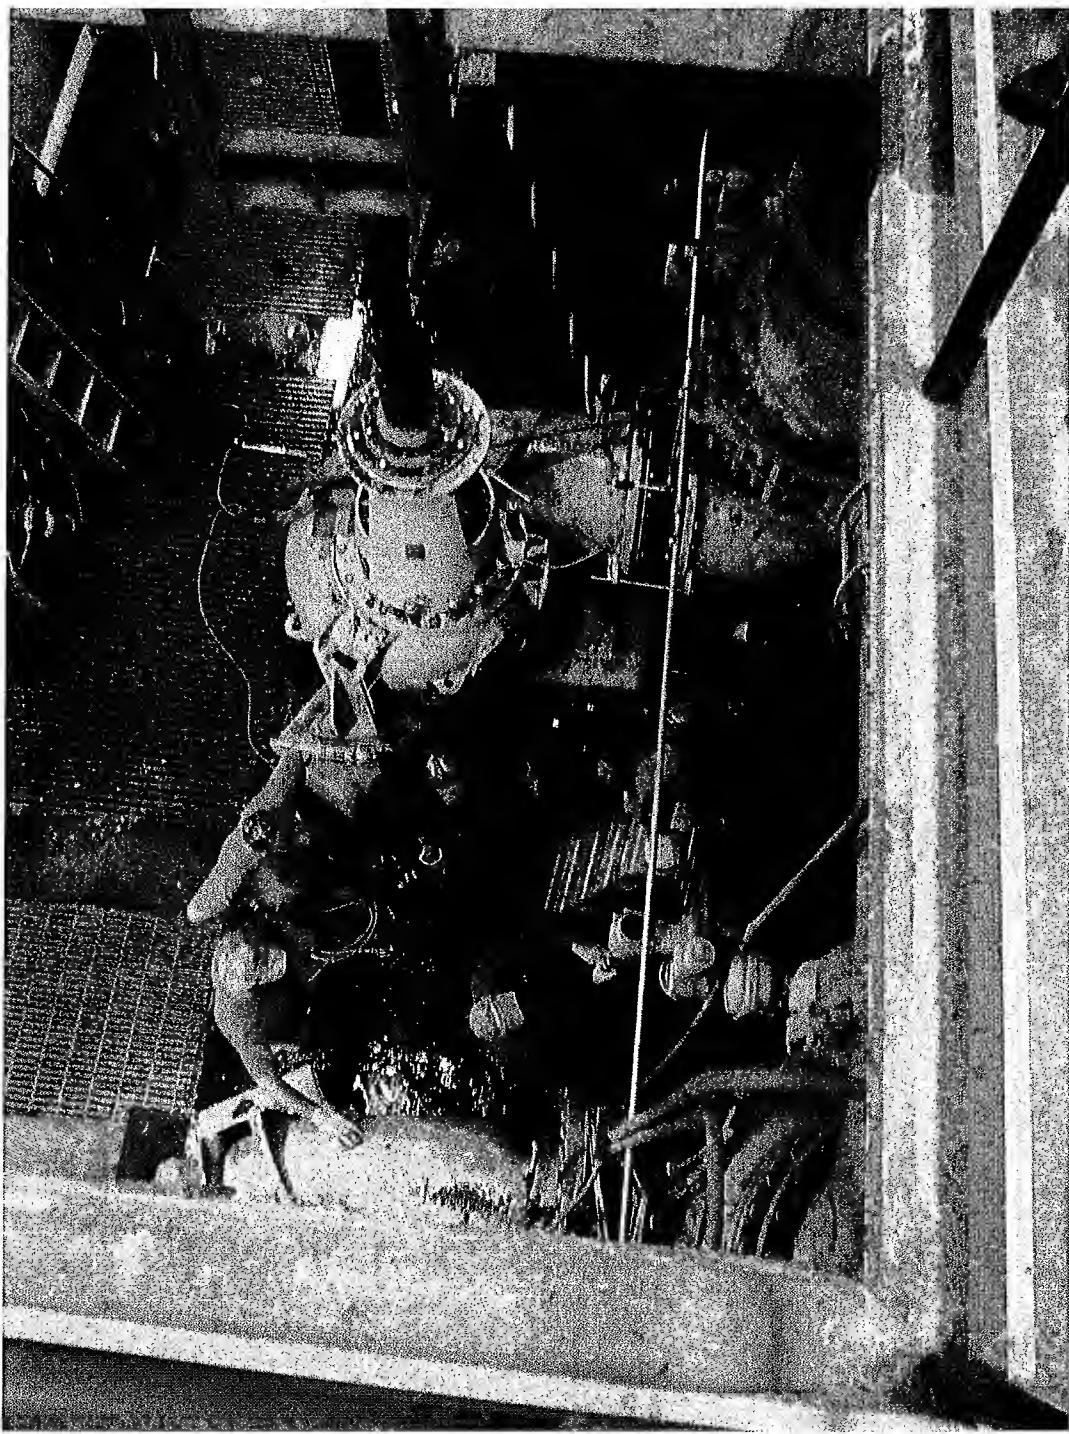
Flooded Dry Pit
